When the flood came at night – July 14, 2021

Matthias Langensiepen, Bonn – August 2021

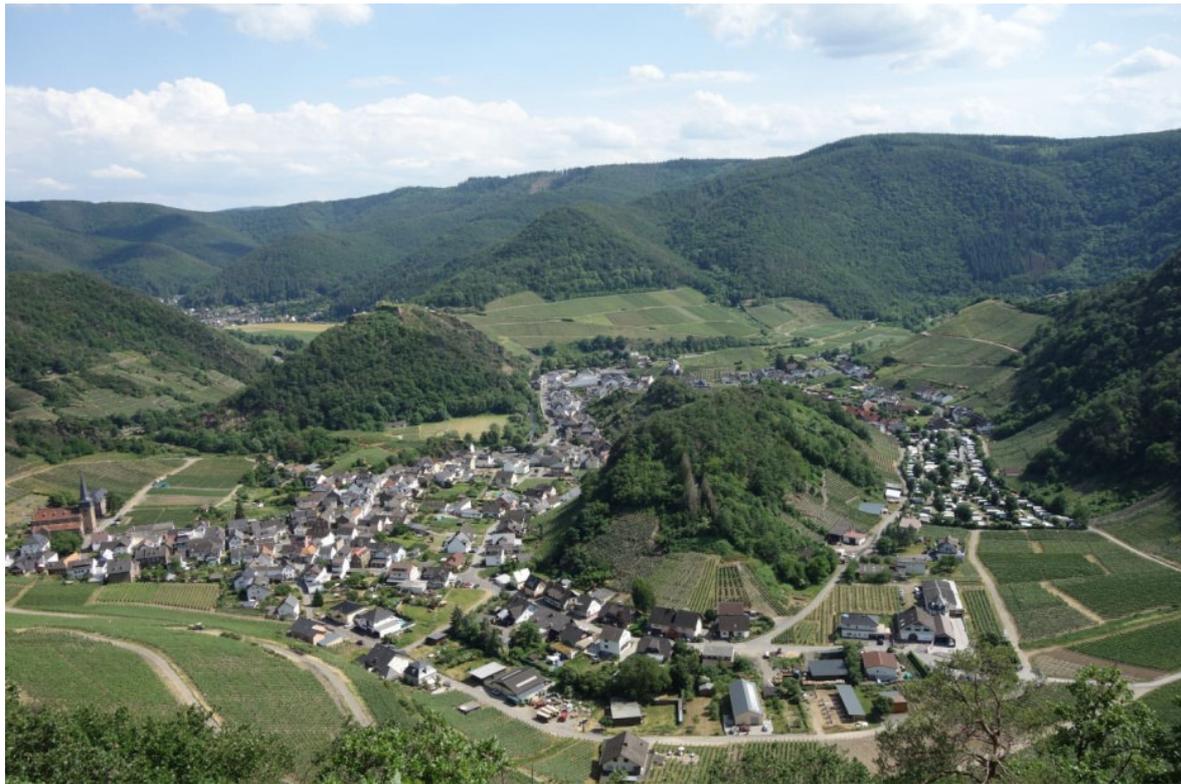
Middle-Ahr at Mayschoß

Meteorological observations of a large trough formation above central Europe suggested an extreme rain event in the Ahr region for July, 14 2021. Soils were soaked from previous rains and unable to take up more water. Warnings issued earlier this week were further substantiated in the afternoon when precipitation intensified and Ahr river gauges reported sharp water level rises far beyond their common ranges. At 6 pm I started monitoring the river gauge at Altenahr on a dedicated website. The water level was about 300 cm at this time, 230 cm above the common level, and sharply rising. It was obvious that something severe would happen.

The gauge stopped recording at 8:45 pm when the water level reached 575 cm. A statistical function was continuously fitted to the measured gauge data up to this time and predicted a maximum level of 700 cm for 5 pm the next morning. Someone operating the website later replaced the fitted curve by a deterministic model which simulated a peak level of 575 cm for 1 pm the next morning, 125 cm less and 4 hours earlier than the fitted function had predicted. As it turned out, discharge data from Müsch located 30 km upstream suggest that the actual peak level could have been 700 cm, as the statistical function had predicted. The model prediction was obviously wrong. This and numerous other examples demonstrate that calibrating deterministic models of natural processes is strongly limited by nature dynamics which cannot always be foreseen. As the Hawaiian colleague pointed out, geological processes shaped the Eifel into a complex terrain. Predicting non-linear fluid dynamics on its highly heterogeneous land-surface is a grand challenge. Considerable basic and applied research efforts are required to make Ahr flood predictions more reliable.

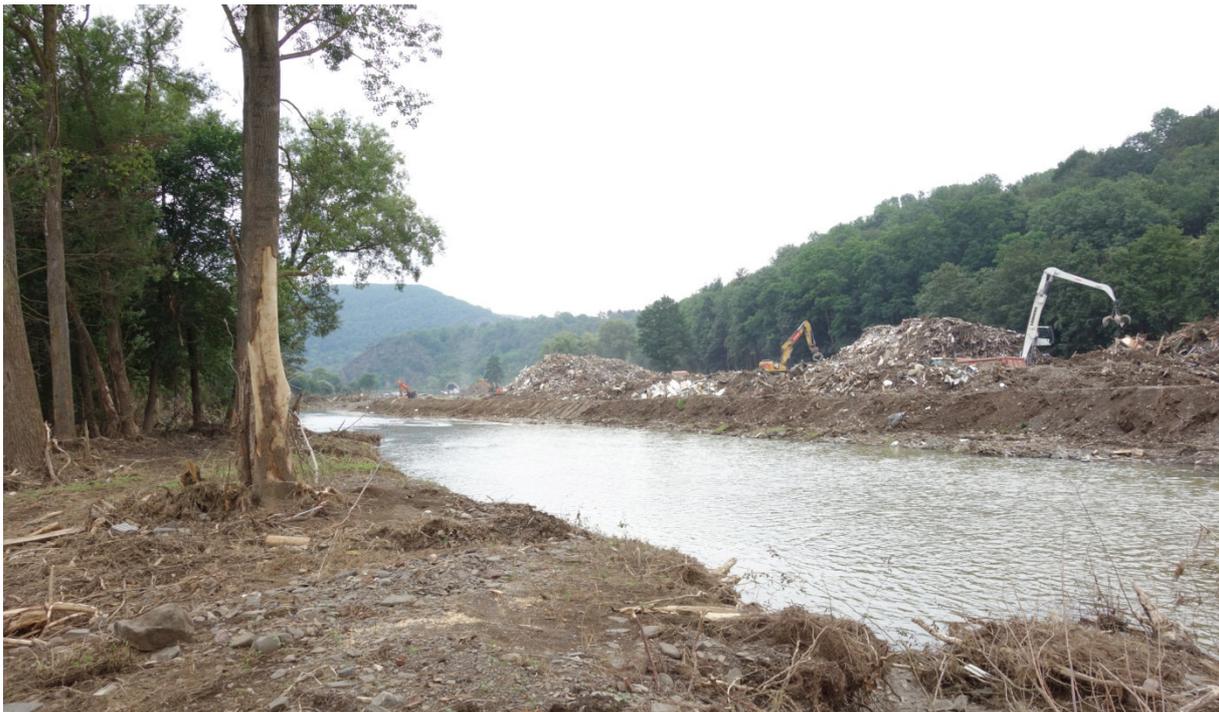
mounting water pressure, releasing high amounts of water to the following bridges where the same happened again in a chain reaction. Trees planted along the Ahr collapsed into the water due to the rapid buildup of kinetic energy which intensified its impact on any obstacle in its way. Two tributaries released additional amounts of water into the meandering wave loaded with trees and debris before it hit the small towns of Schuld and Insul, causing extreme destructions reported on all news channels around the globe. The wave came so quick that people had hardly any time to rescue themselves. There was a sudden power cut, leaving them in the dark. Enormous amounts of water poured into their houses. Many narrowly escaped drowning and made it to higher floors or roofs, if their houses did not collapse under the force of the river. It continued downstream until Adenauer Bach, a major tributary, which added additional extreme amounts of water into the Ahr. Passing Liers and Hönnigen, the wave crushed with additional amounts of trees into the small town of Ahrbrück, destroying its bridge, carrying houses away and flooding other houses to the first floor level. It continued further to Kreuzberg, a few kilometers downstream, taking a shortcut, leaving huge amounts of trees, debris, house items, cars, trucks, camping vehicles and any other imaginable material along the river edges, piled up to 10 meters during the following clean-up.

Clean-up of flood debris near Kreuzberg three weeks after the flood

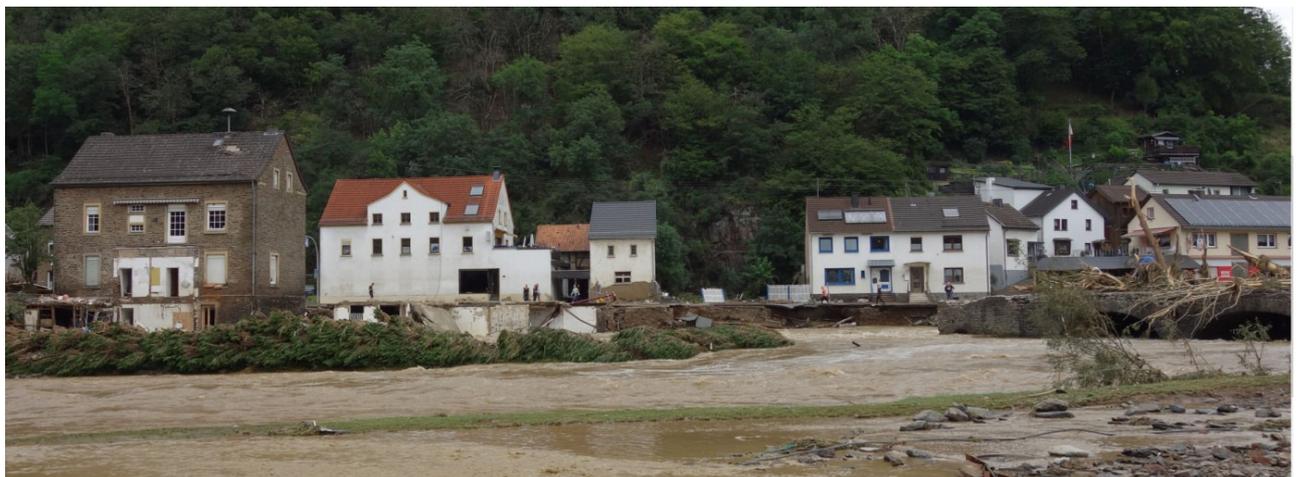
The morning after the flood at Ahrbrück

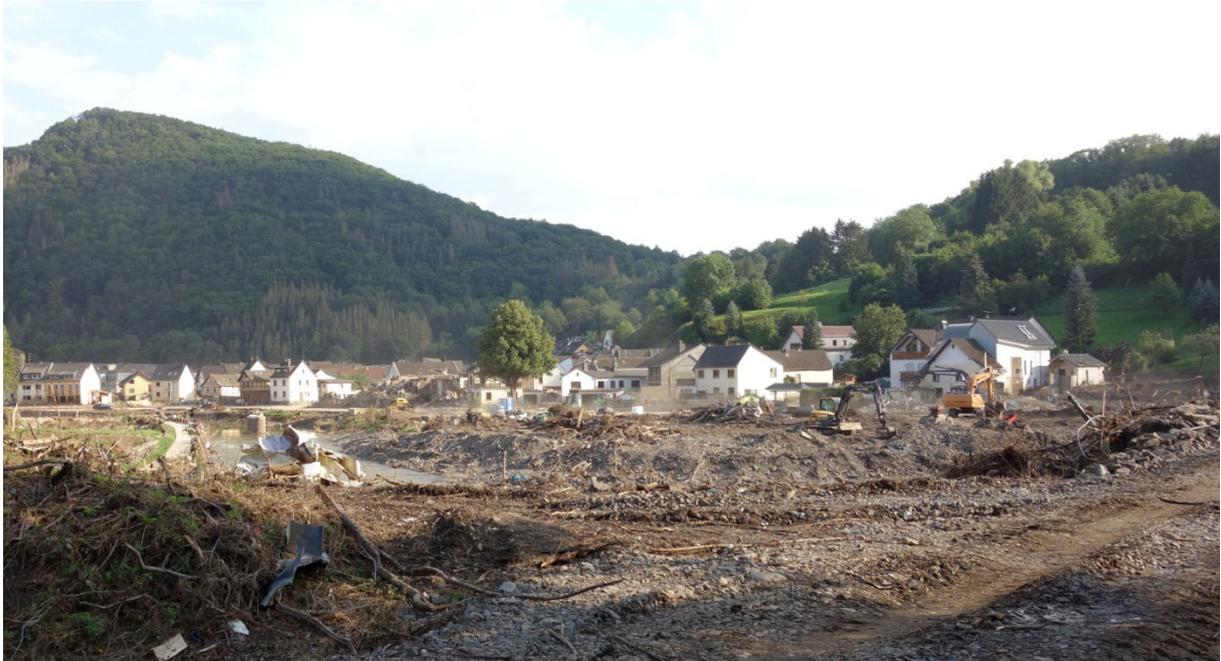
Sahrbach, another large stream, loaded additional extreme amounts of water into the Ahr before it continued through the small town of Altenburg which was double-affected by the wave, first when it released its destructive force into downstream direction, and later into upstream direction when it bounced back from a bridge blocked with flood material at Altenahr at Altenahr, setting the entire village under water. Altenahr was declared a disaster area at midnight, allowing the army to move in and help with heavy machinery, as it did later along

Altenburg, inundated twice in a short period of time by a flood wave that bounced back from a natural barrier at nearby Altenahr.
